## BRONZE CLOSE COUPLED RUBBER IMPELLER PUMP

PIPE SIZE: 3/8" ID AND 3/4" OD GARDEN HOSE

MODEL  
N211M

## EXPLODED VIEW AND PARTS LIST

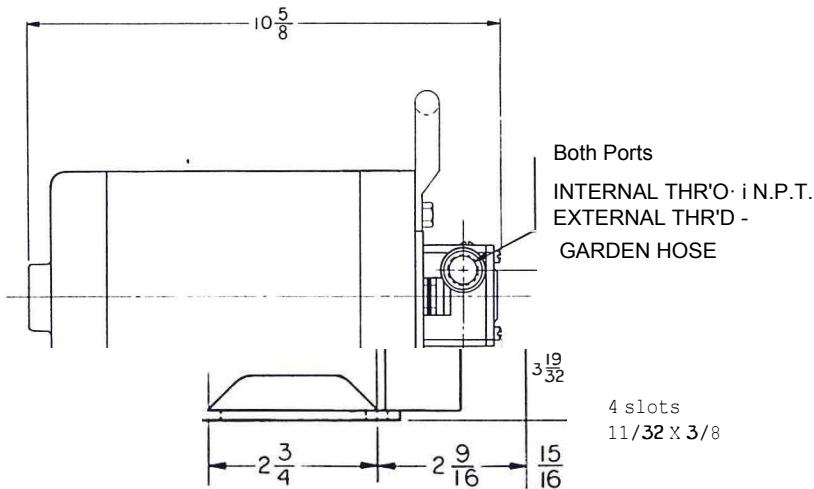
## DIMENSIONS

Motor drive is clockwise facing pump end. Liquid flow direction is right to left facing pump end - see dimension drawing on reverse side. Motor is 1/6 HP, 3450 RPM, 115VAC. O.D.P.
